# **VEHICLE ENGINEERING**

**SPACE SHUTTLE PROGRAM**  
**Space Shuttle Vehicle Engineering Office**  
NASA Johnson Space Center, Houston, Texas

## Orbiter STS-111 CoFR

# STS-110 RCS THRUSTER FAILURES

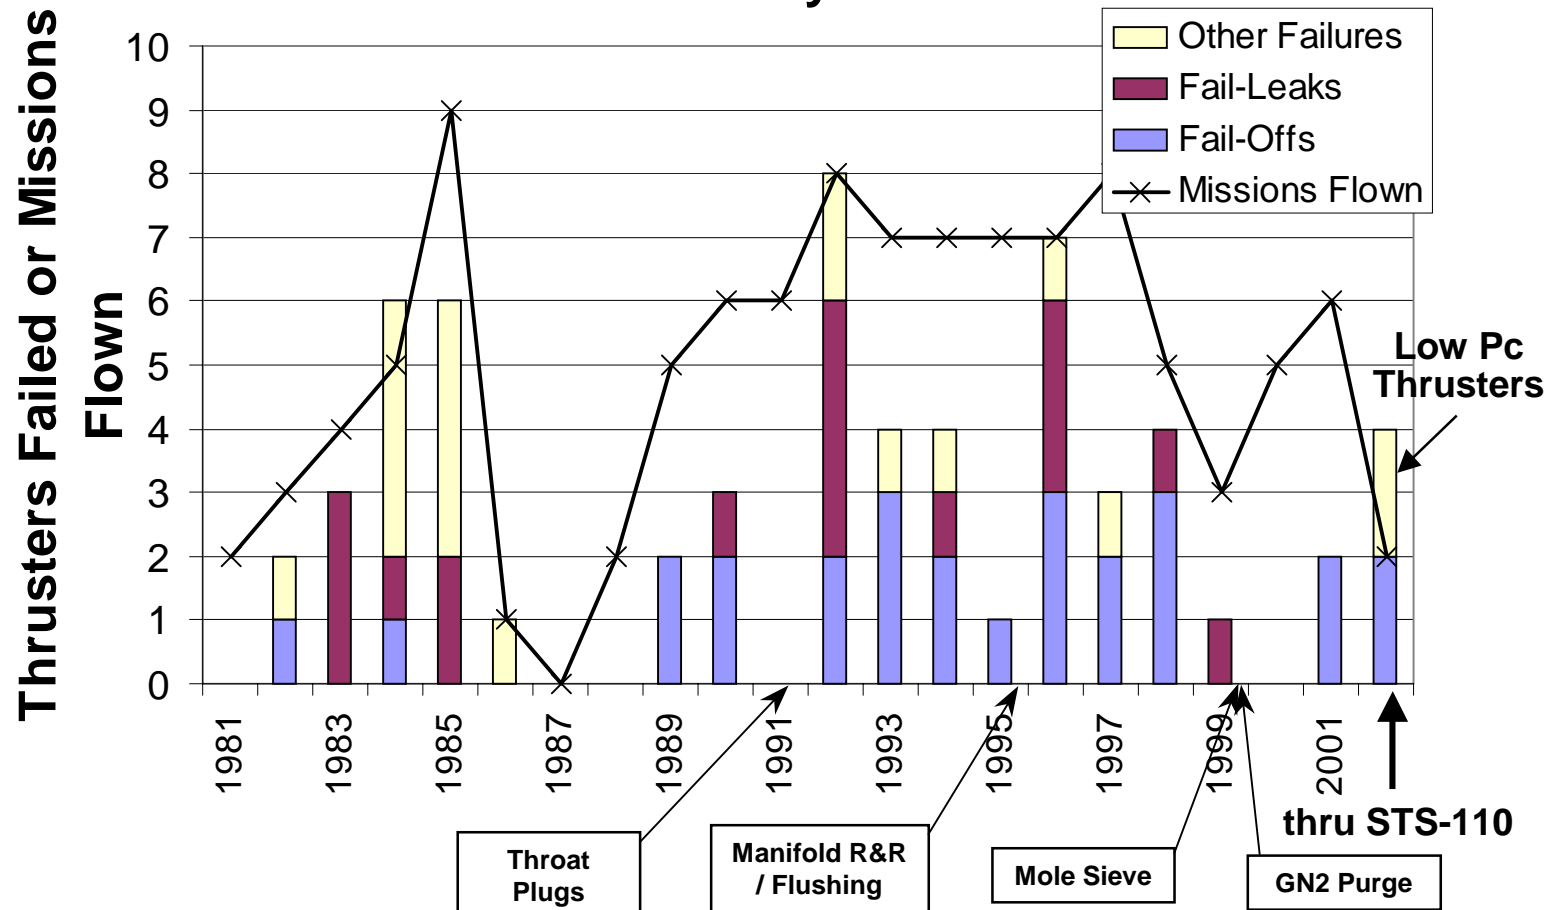
## Shuttle Orbiter RCS Thruster In-Flight Failure History

- Due to recent increase in thruster failures (6 in the last 3 missions) a team has been formed to re-evaluate thruster processing at WSTF and KSC and current failure risk mitigation procedures
  - Valve/thruster build-up
  - Acceptance testing
  - KSC installation/checkout
  - Risk mitigation processes
    - GN2 purge, flushing, throat plugs
  - Flight usage/changes
  - Correlate failures with flight history/processing
- Preliminary schedule of team activities:
  - Initial core team meeting to review data and define activities and milestones leading up to TIM: 5-13-15/02
  - Full team TIM: mid-June, 2002
    - Establish schedule for period progress reporting and target completion date for recommendations

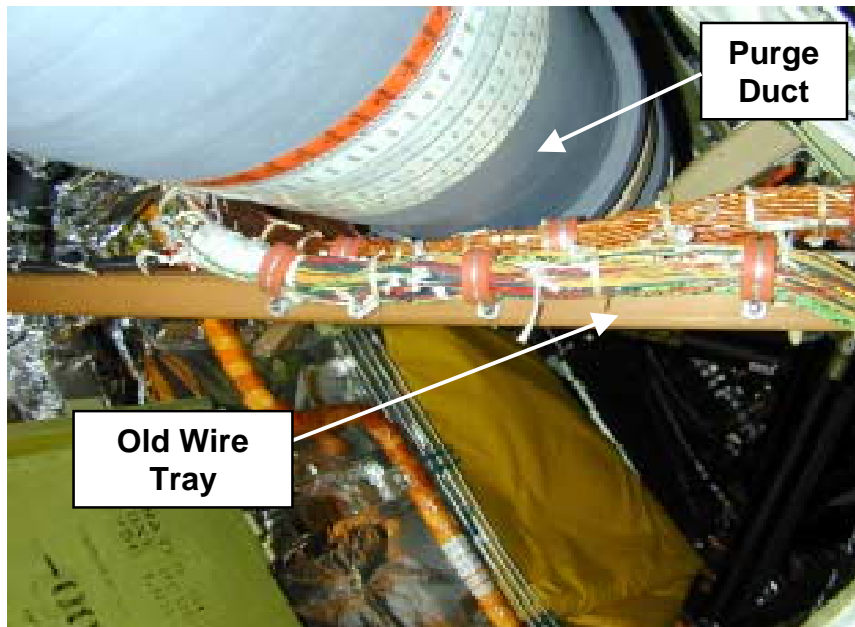
Original Crossover Bracket Design

- Condition has been accommodated by MR utilizing tie-wraps and harness routing that minimizes the interference and teflon wrap to protect the harnesses in the contact area

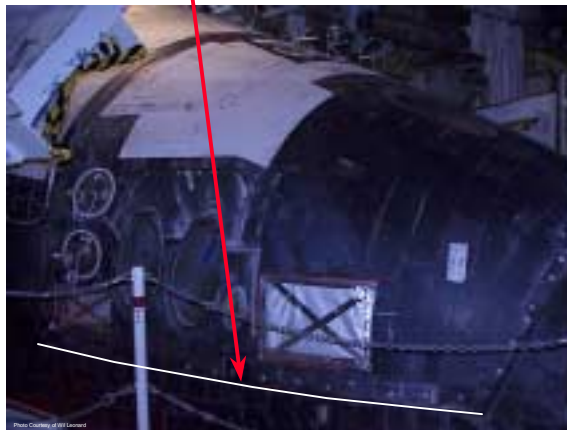
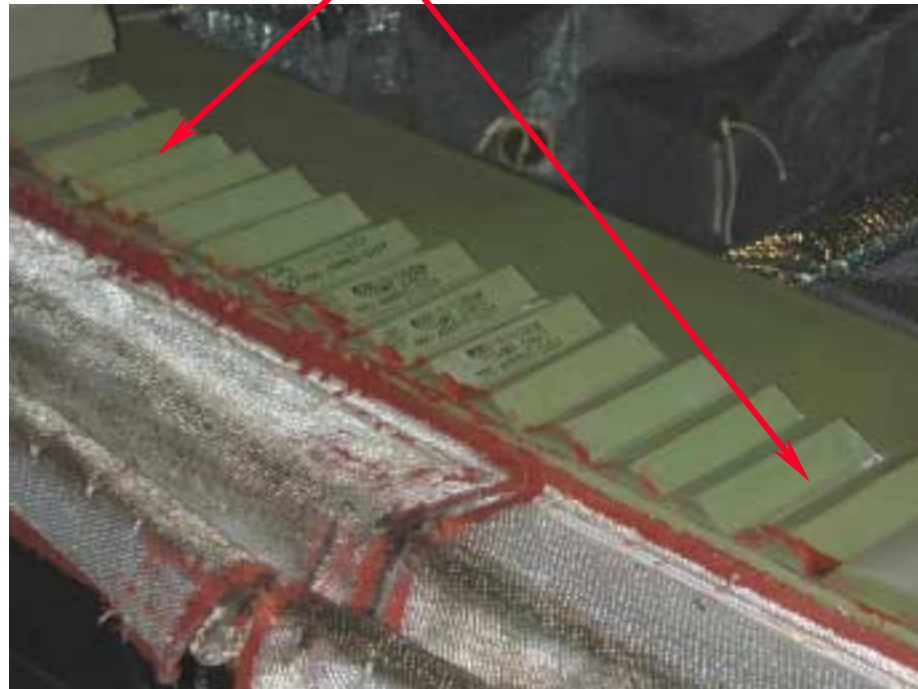
FRCS Thermal Clips on Lower  
Forward Fuselage Interface

- Deletes the thermal transfer clips from the interface between the FRCS module and lower forward fuselage
- Installation of these numerous clips is a time consuming process during FRCS mate
- Thermal analysis indicates that the clips are not required as their removal will not cause structural thermal gradient concerns
- Work savings process improvement for ground ops

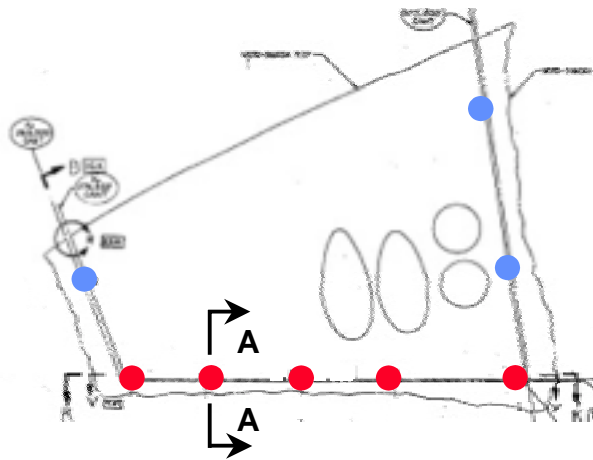
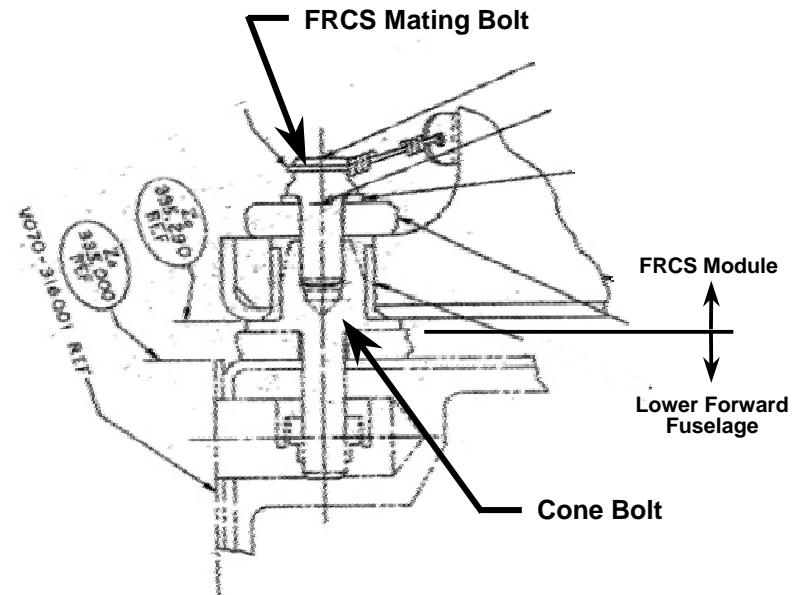
FRCS Module – Side View

- The FRCS is attached to the forward fuselage at 16 locations
  - The 10 Z-direction mating bolts fasten through the FRCS into cone bolts, which are threaded into the lower forward fuselage and contain a threaded female feature in the cone that receive the mating bolt
- During a recent inspection of OV-102, 4 of the 10 cone bolts had less than the required installation torque
- Investigation revealed that the cone bolt installation torque was to class 1 and the FRCS mating bolt was to class 3
  - Removal of the mating bolts at the higher torque level is believed to have caused the loss of torque on some of the cone bolts
- The design change revised the installation torque of both the cone bolts and the FRCS installation bolts to a class 2 torque to preclude this condition
  - FRCS installation OMI to be revised to require cone bolt torque verification prior to module installation

- Z-Direction Attachment Locations – 5 LH / 5 RH
- X-Direction Attachment Locations – 4 Aft (2 LH / 2 RH) 2 Fwd (1 LH / 1 RH)

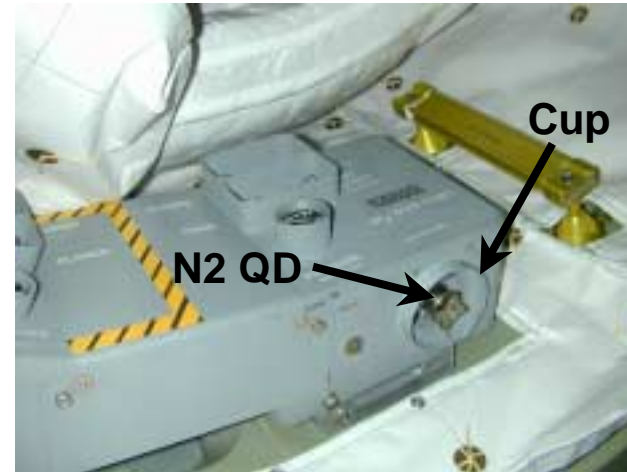
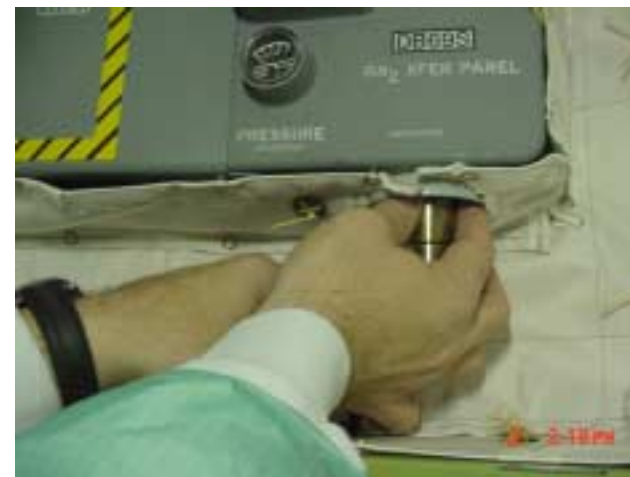
### MCR 19670 Nitrogen Transfer Hose Quick Disconnect Release Ring

- The ISS N2 flexible transfer hose attaches to the external airlock N2 transfer panel via a QD
  - The N2 transfer hose remains on the ISS and is mated following docking and hatch opening
  - Hose QD must be able to be quickly released in the event of an emergency undocking
- During STS-110 CEIT, the crew had difficulty gripping the releasing ring to demate the N2 transfer hose QD from the transfer panel
  - Difficulty was caused by the recess of the QD within the “cup” and “cup” diameter

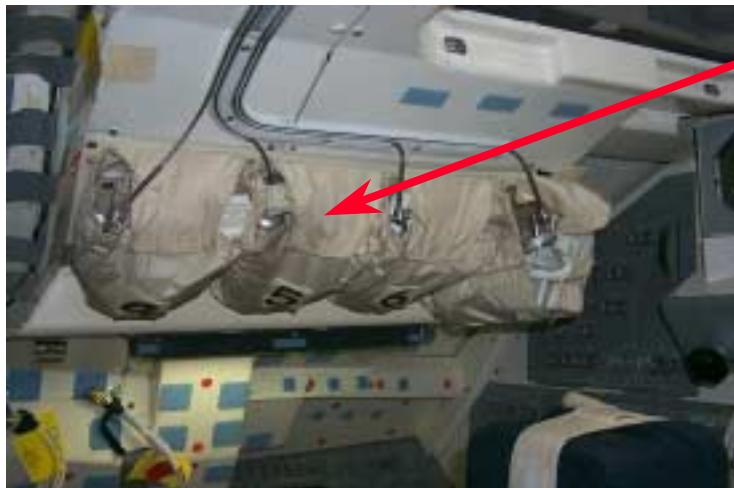
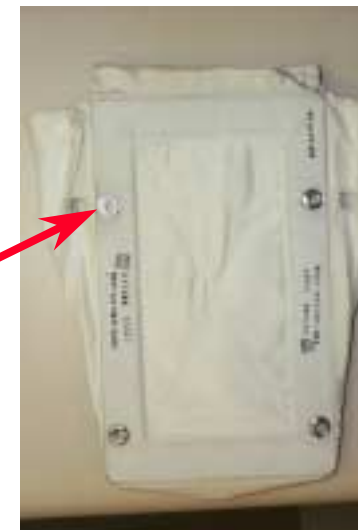
Mounting  
Fastener  
Grommets  
(4 per pouch)

- Crushed sky genie pouch mounting fastener grommets were observed prior to OV-105's previous mission
  - Attributed to torque engagement force of fully-threaded screw
- For STS-111, grommets were repaired (returned to print) and installation fasteners changed to shoulder bolts to prevent grommet damage

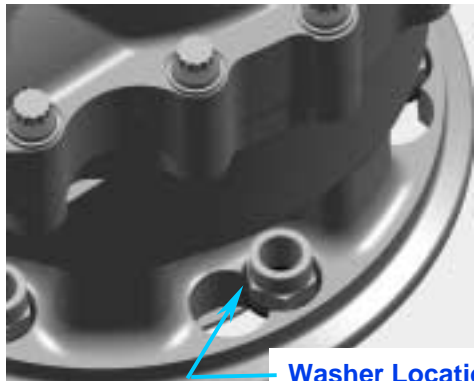
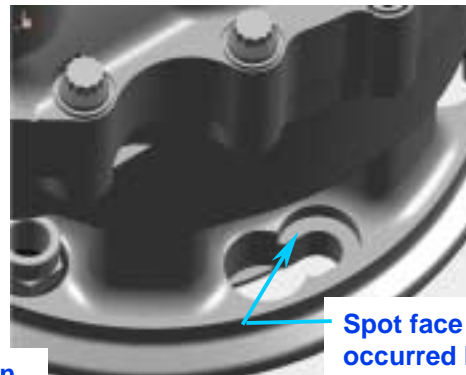
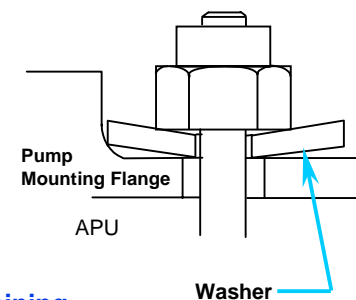
Washer Location

MCR/Modification	Certification Method			Certification Approval Request No.	Approval Date	Remarks
	Test	Analysis	Similarity			
MCR 12999 Main Hydraulic Pump Mounting Flange Washer Modification		X		04-30-580100-001F	3/26/02 A	<ul style="list-style-type: none"> <li>During installation of APU 3 on OV-102, it was noticed that the washers used on the main hydraulic pump mounting flange were 'cupped'</li> <li>A recent change had been made to increase the washer outside diameter to prevent coining of the pump mounting flange <ul style="list-style-type: none"> <li>Larger diameter increases load bearing area / distribution</li> </ul> </li> <li>Tolerance study indicates that worst case conditions could cause the larger diameter washer to hang up in the spot face radius <ul style="list-style-type: none"> <li>Application of nut torque causes the washer to bend or cup</li> </ul> </li> <li>Over time, cupped washers may relax, resulting in loss of preload, which could result in reduced joint fatigue life</li> <li>Modification installed redesigned washers with a slightly reduced outside diameter to accommodate tolerance conditions and eliminate the installation interference (PR-EO to Follow)</li> </ul>

Spot face coining  
occurred here

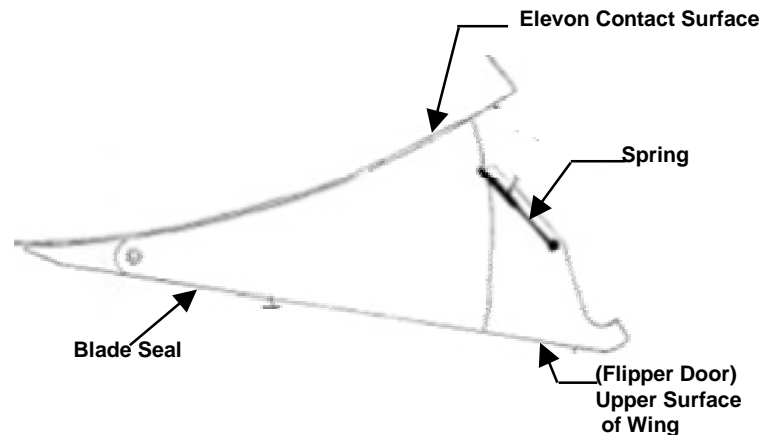
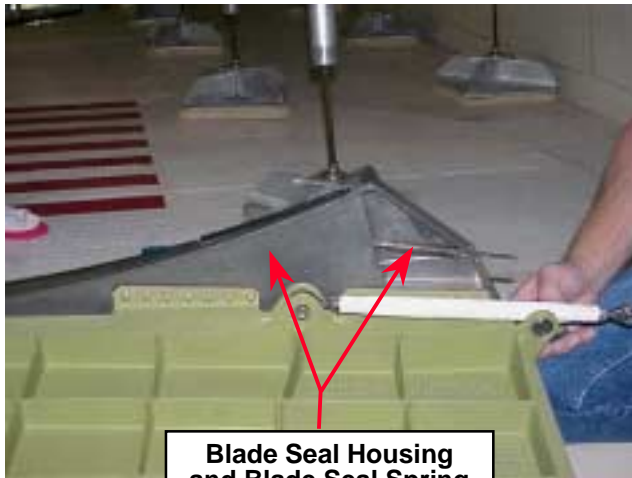
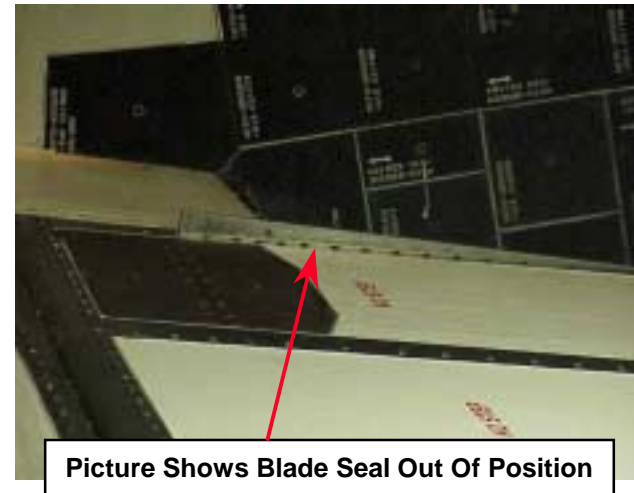
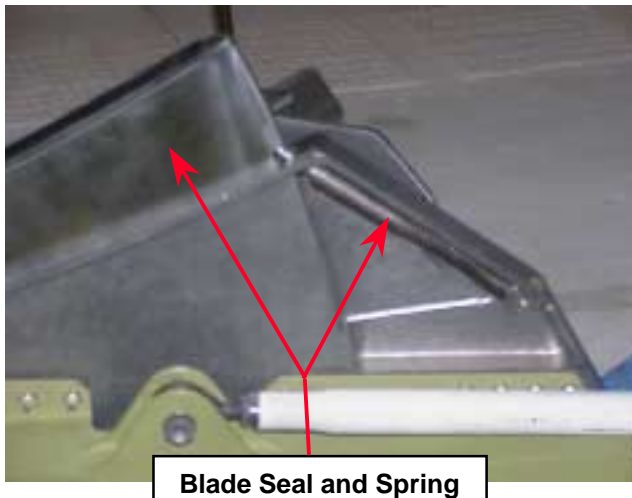
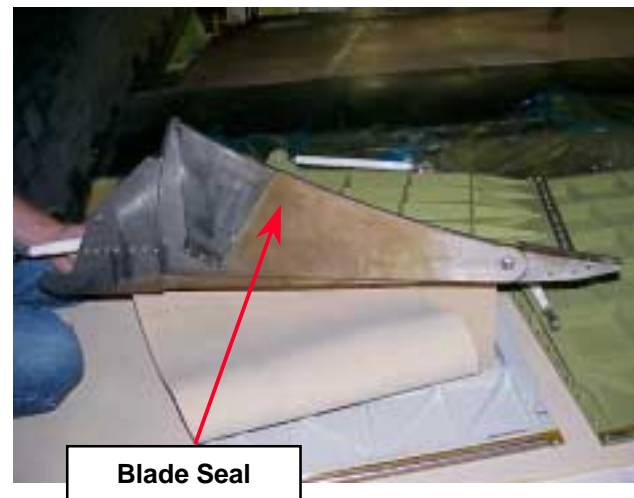
## MCR 1955 Elevon Blade Seal Modification

- The inboard elevon blade seals are not remaining seated against the elevon mating surface during the orbiter/et mating process.
- Prior to Orbiter/ET mate the elevons are fully dropped. When the orbiter goes vertical the elevons slowly drift to approximately null position. Because of this slow drifting the LH&RH blade seals don't slide down and seat against the elevon mating surface. The frequency of this problem is increasing.
- Design change replaces the old blade seal springs with new, stiffer springs
  - Increases the spring force and allows the blade seal to reseat itself

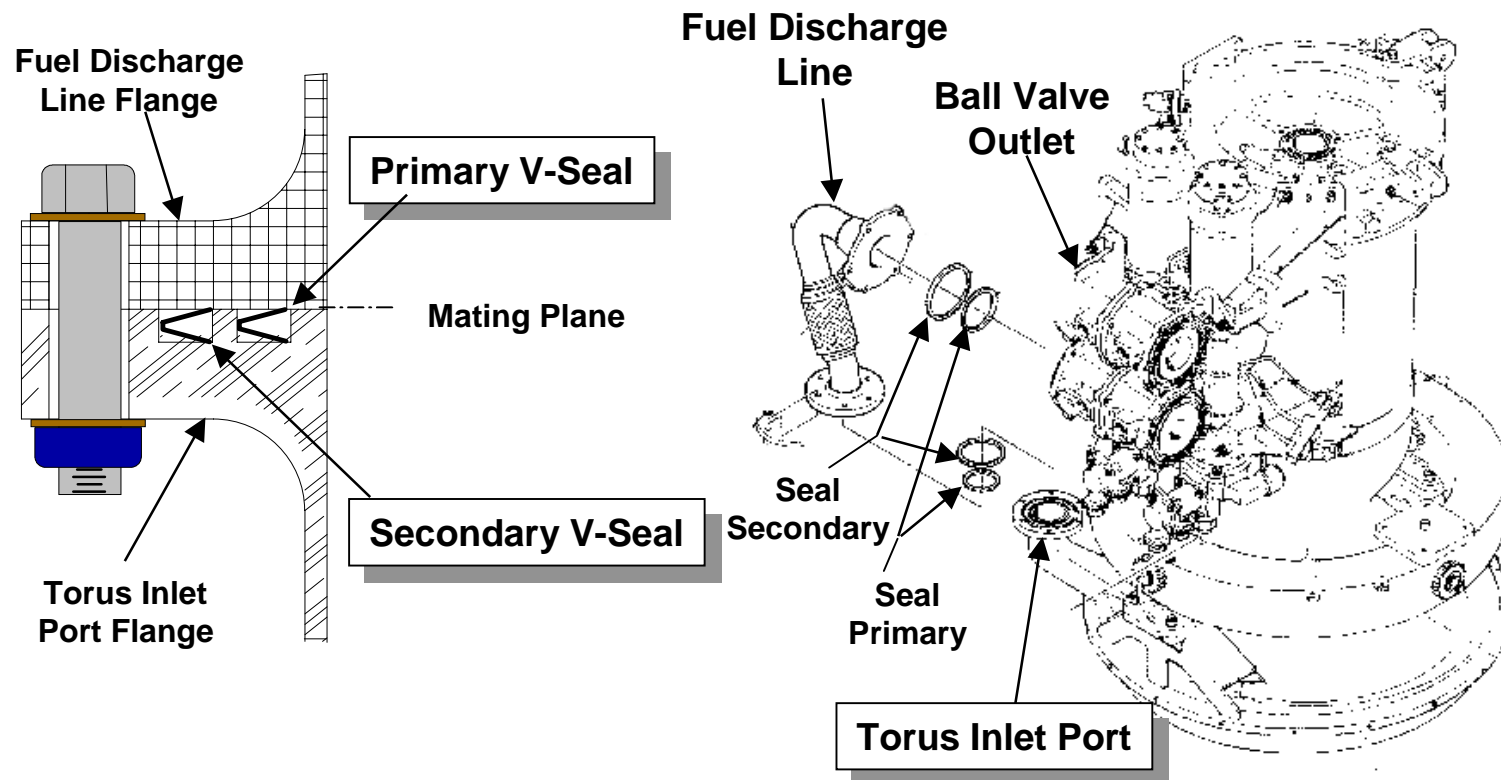
Fuel Discharge Line - Torus Inlet Port  
Mated Joint Section View

- Fuel discharge line flange seal changed from Omni-seal to V-seal design with increased bolt torque in mid-1990s
  - Increased torque requirement recently discovered to be beyond rated capability of existing bolt (6 bolts per flange)
- MR procedure implemented to replace suspect A286 bolts with stronger MP35N bolts at a reduced torque on both OV-105 OMS engines
  - Maintains safe bolt preload and large positive margin for prevention of joint gapping
  - Bolts replaced one at a time per validated vendor bolt torque pattern procedure to retain seal integrity
  - OMRSD GHe leak check performed to validate flange joint following bolt replacement
- Certification deviation processed

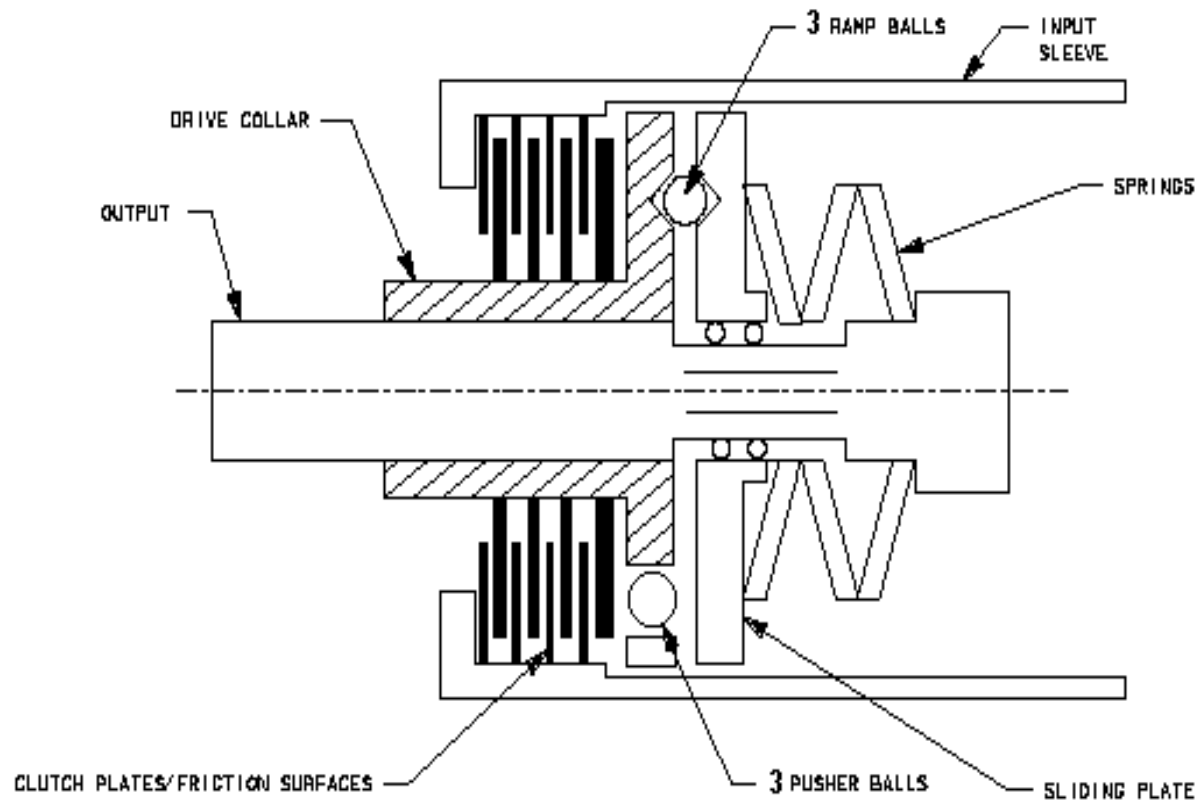
## Simplified Torque Limiter Schematic

- This anomaly remains an unexplained anomaly
- The previous most likely cause of dynamic contact between the two torque limiter plates has been ruled out by test
  - Stall max torque testing was performed while adding shims using a transfer coating to determine if plate contact had occurred
  - Dynamic contact did not occur until plates were also in contact statically
- Other potential causes including a reduction in the coefficient of friction continue to be investigated
  - The qual torque limiter was assembled and set to a specific Belleville stack height (slip torque measured to be 475-485 in-lbs)
  - The torque limiter was disassembled, cleaned, reassembled, and set to the same Belleville stack height (slip torque 655-675 in-lbs)
